# LADOTD DAM INSPECTION AND EVALUATION REPORT

Inspection Date: 07/21/2026

Name of Dam: Caney Creek

NID ID #: LA00385

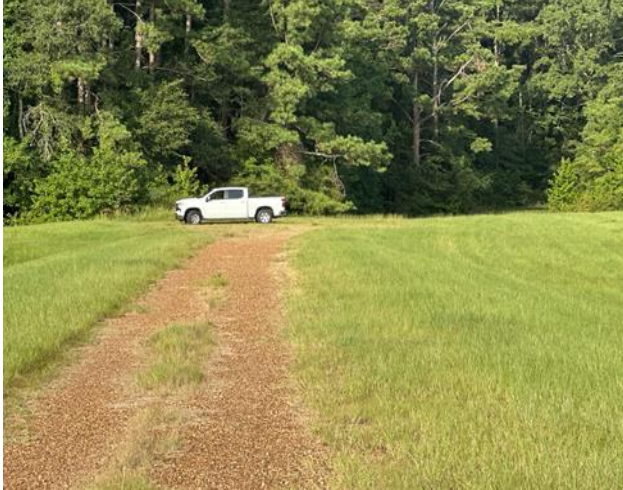
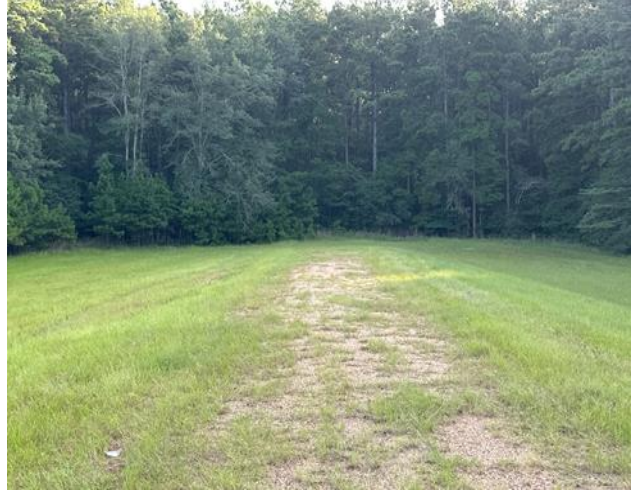
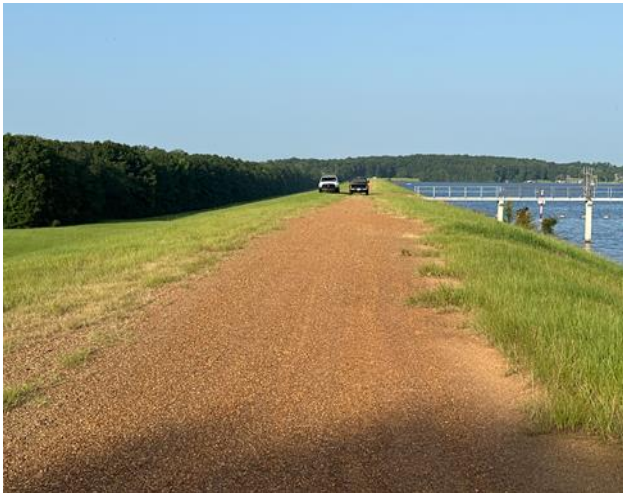
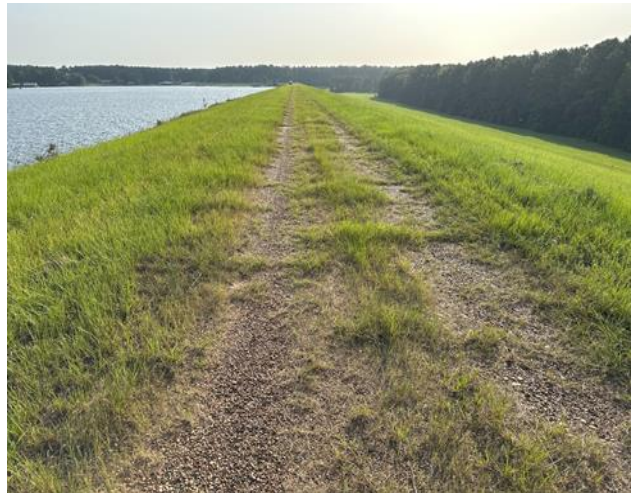
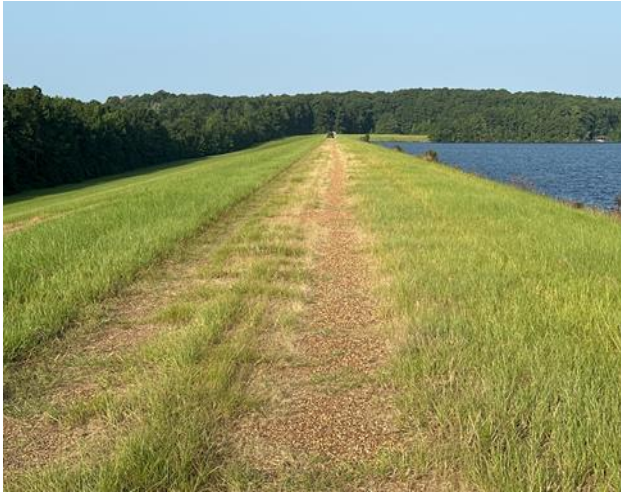
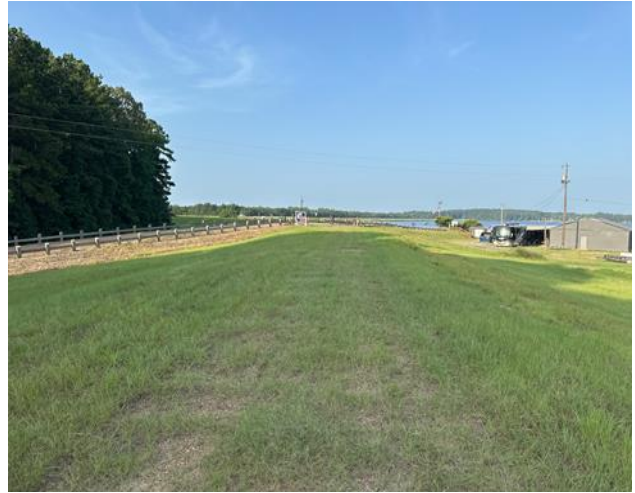
**Crown Width (Ft.):** 30  
**Crown Length (Ft.):** 6190  
**Crown Description:** Earthen crown with aggregate access road surface  
**Fence:** None  
**Abutment:** Adequate  
**Comments:** Crown is accessible to vehicles and in good condition.

*No deficiencies identified*

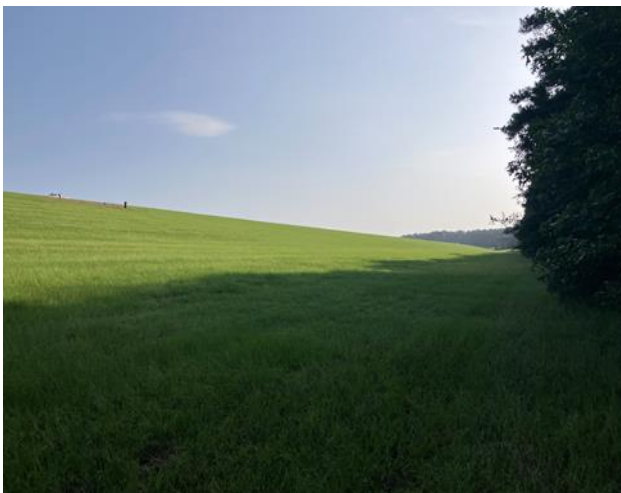
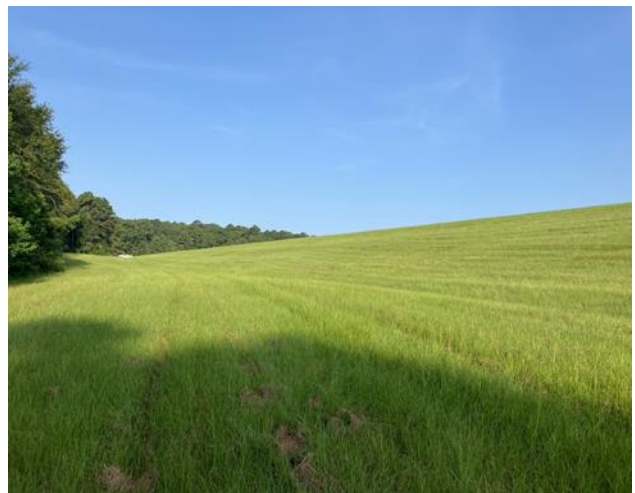
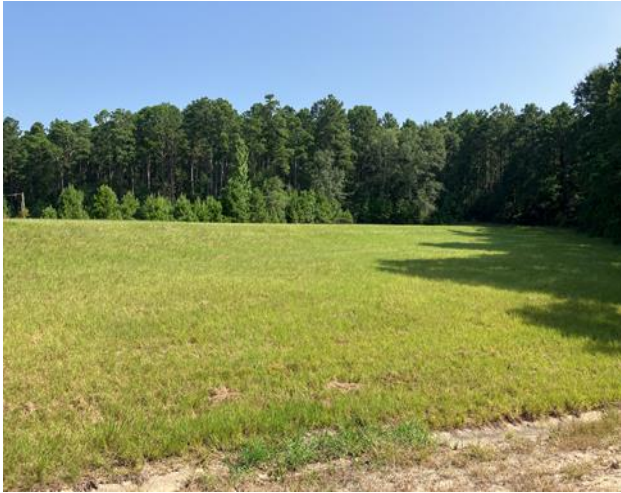
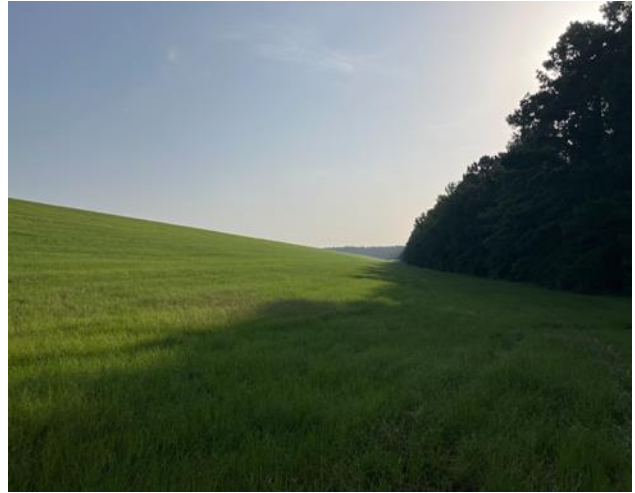
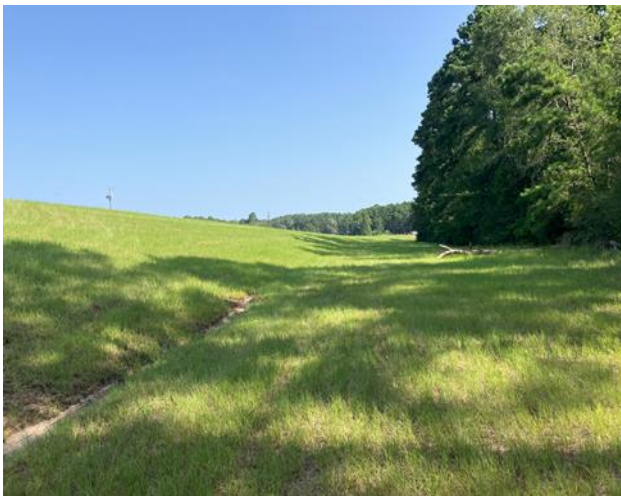
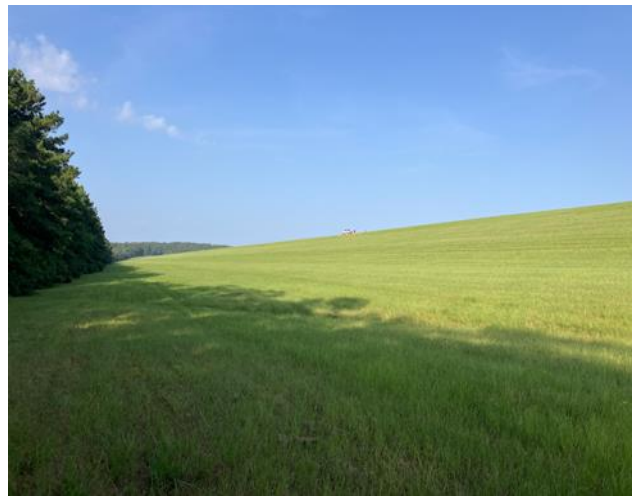
| <b>Embankment Description:</b> | Embankment in excellent condition. |
| <b>Comments:</b> | mowed in good condition, but there are three downed trees on the dam that should be removed. |

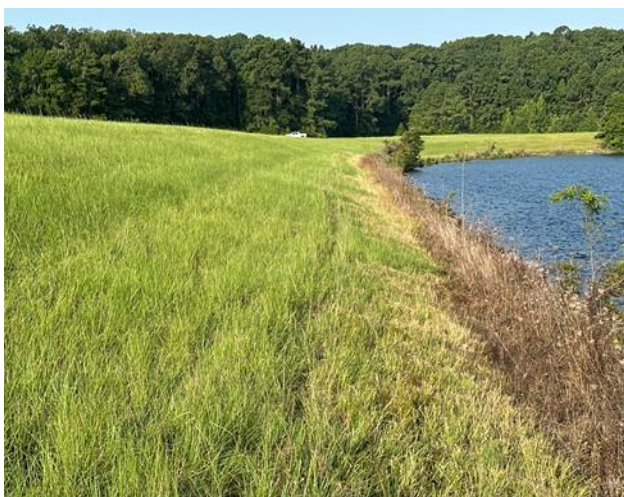
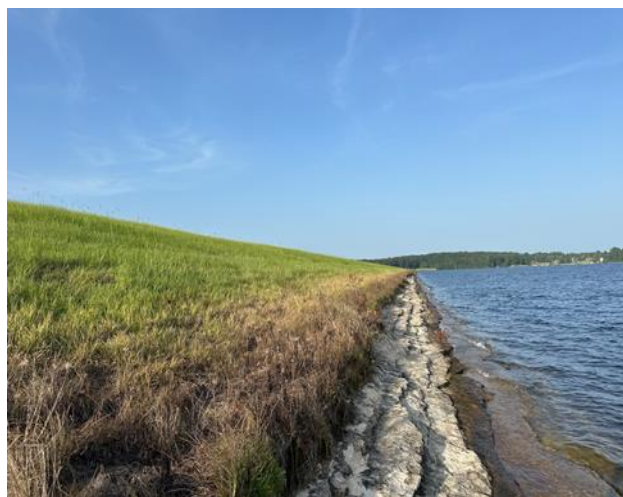
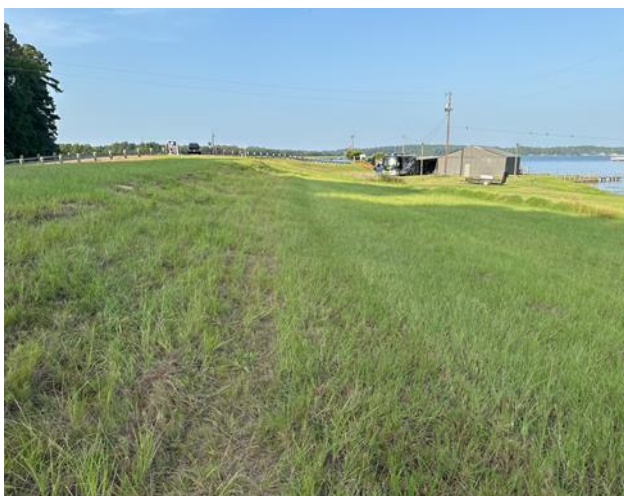
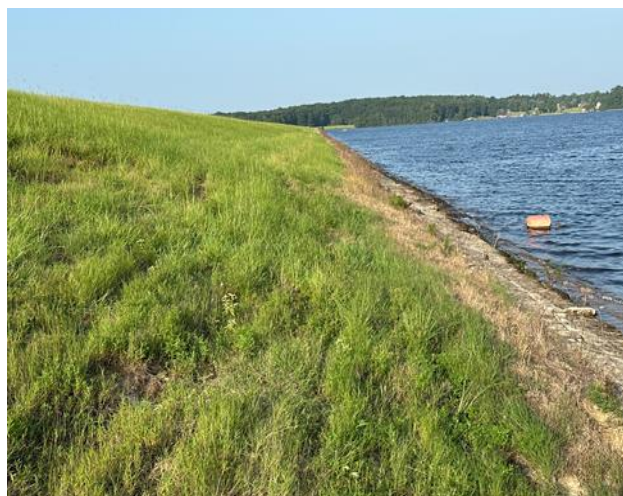
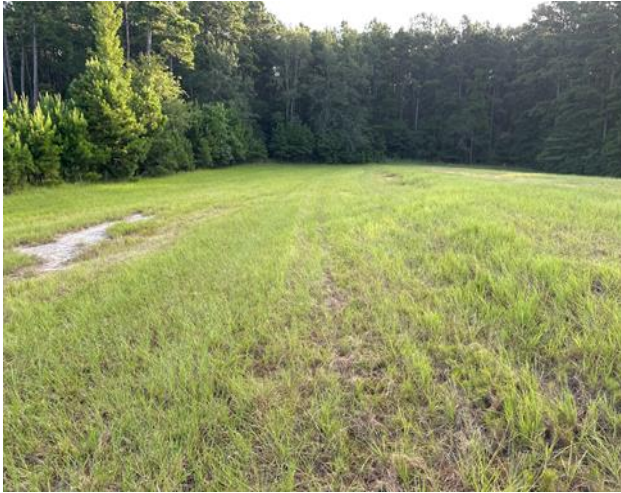
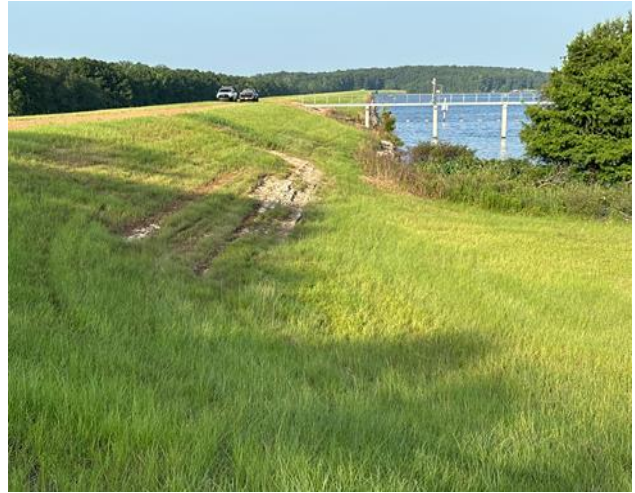
The upstream shore protection consists of cement stabilized soil from elevation 190 feet MSL to elevation 210 feet MSL, or the wave zone. Near the western end of the embankment, broken concrete has been placed on top of the moderately deteriorated cement.

Upstream embankment area where riprap is present and edge of toe has been recently sprayed and is generally in good condition. Several small bushes on dam that should be removed. Per DOTD, they will be removing additional bushes/shrubs soon.

| Type | Description | Corrective Action |
|---|---|---|
| Unwanted Vegetation (Minor) | Minor vegetation growth (<6 in. Dia.) or small overhanging/fallen branches within the dam section. | Remove vegetation by cutting, trimming or using approved herbicide. Remove unwanted vegetation from the dam section, or within 15 ft. of the embankment toe to facilitate maintenance operations and / or maximize spillway efficiency. |

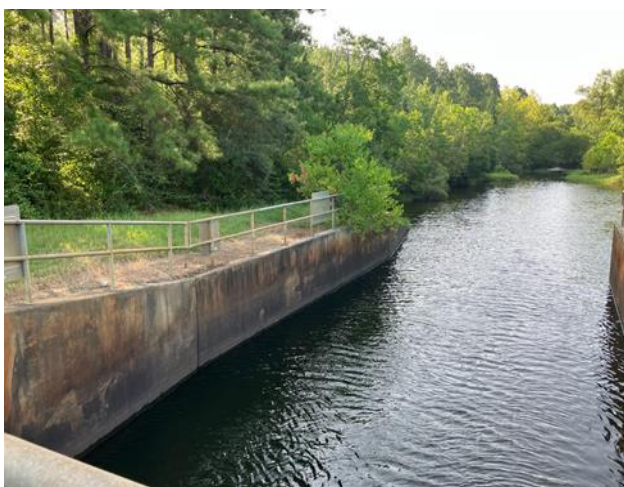
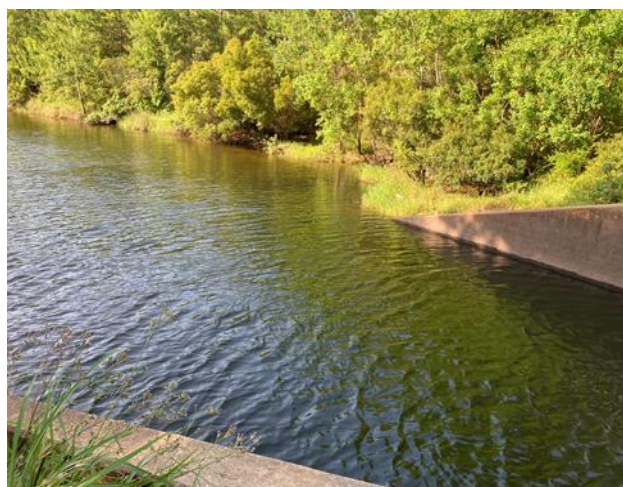
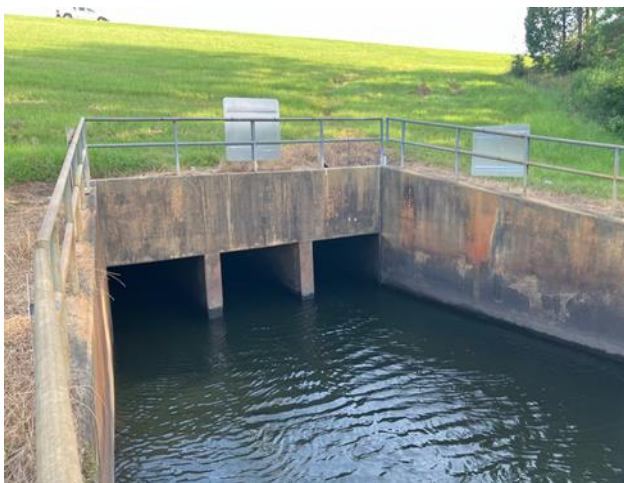
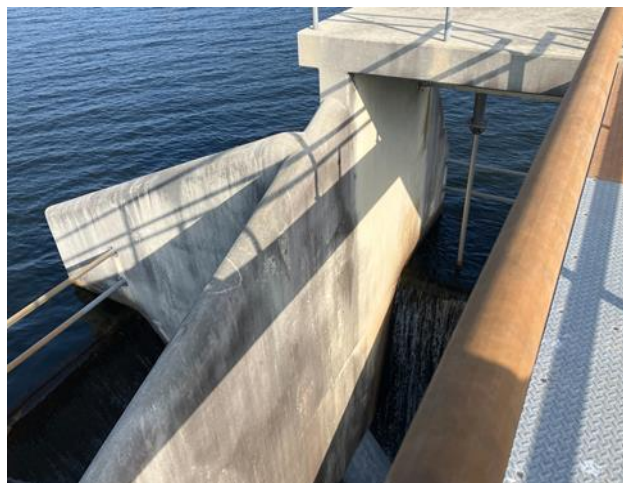
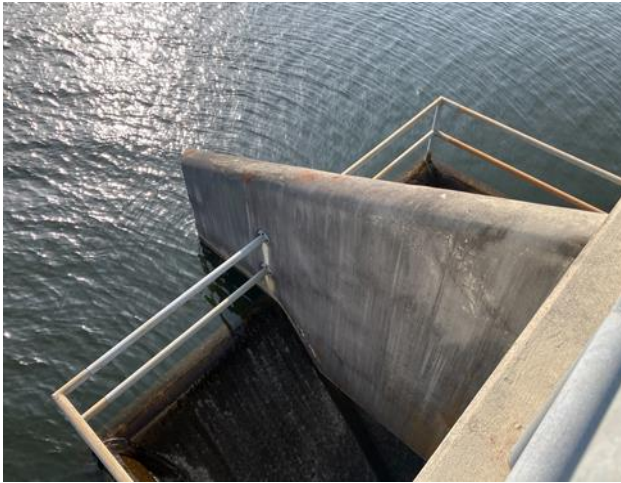
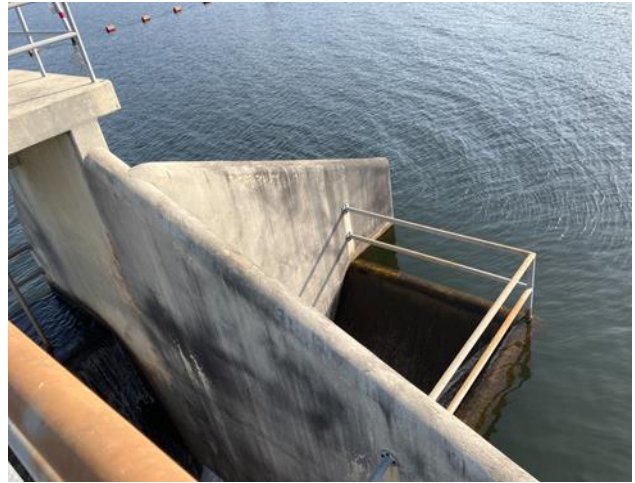
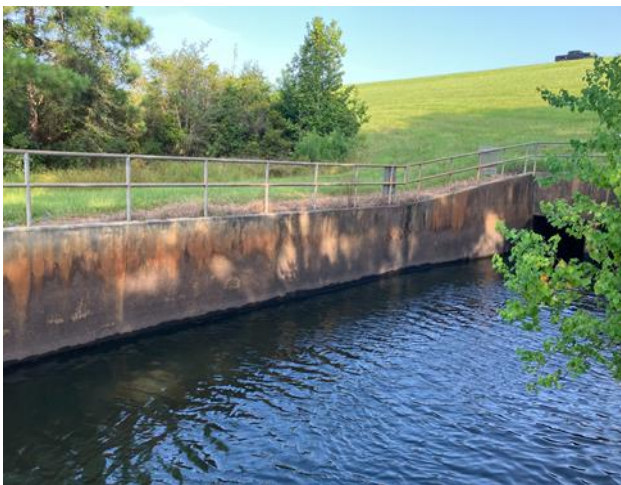
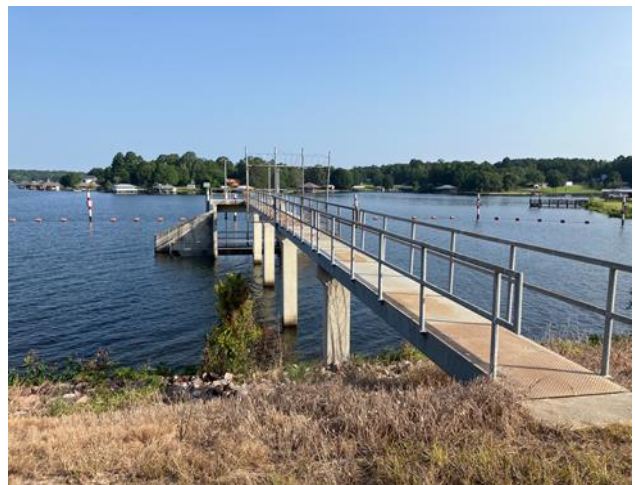
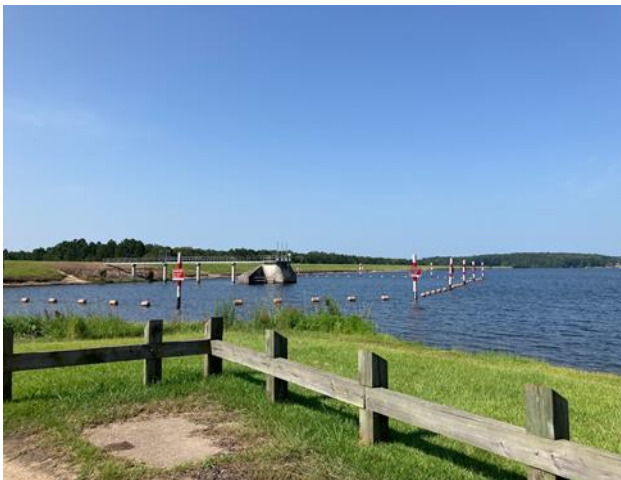
| <b>Comments:</b> | Spillway and outlet works in good condition. No significant cracking, settlement, joint separation, or vegetation visible. There some minor deterioration of the lower portion of a few joints of the tunnels that should be monitored. There is one small tree sprouting on the downstream headwall that needs cutting. |

| Type | Description | Corrective Action |
|---|---|---|
| Unwanted Vegetation (Minor) | Minor vegetation growth (<6 in. Dia.) or small overhanging/fallen branches within the dam section. | Remove vegetation by cutting, trimming or using approved herbicide. Remove unwanted vegetation from the dam section, or within 15 ft. of the embankment toe to facilitate maintenance operations and / or maximize spillway efficiency. |
| Spawling (Minor) | Minor spawling of the concrete was observed. | Monitor the spawling area and make appropriate repairs as needed. |
| Cracking (Minor) | Surficial cracking | Monitor for changes, and if changes occur have the structure evaluated by a professional that recommends remedial measures that are implemented. |

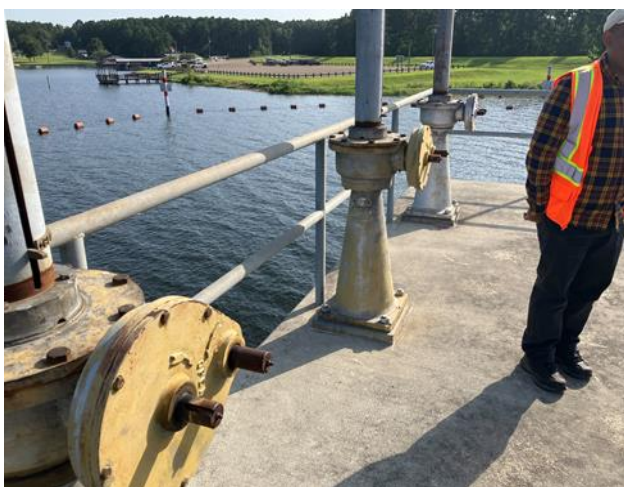
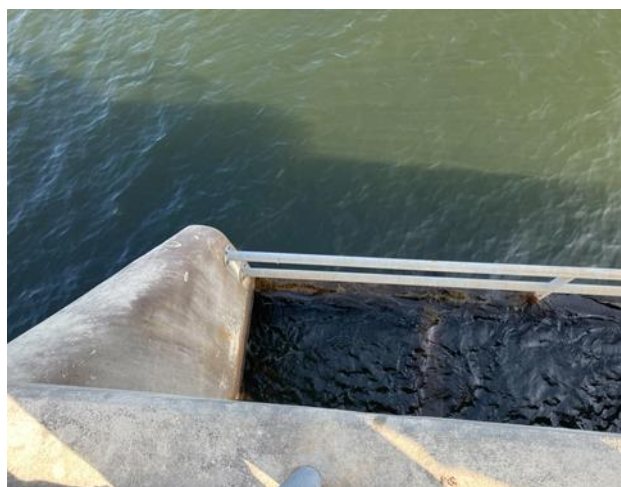
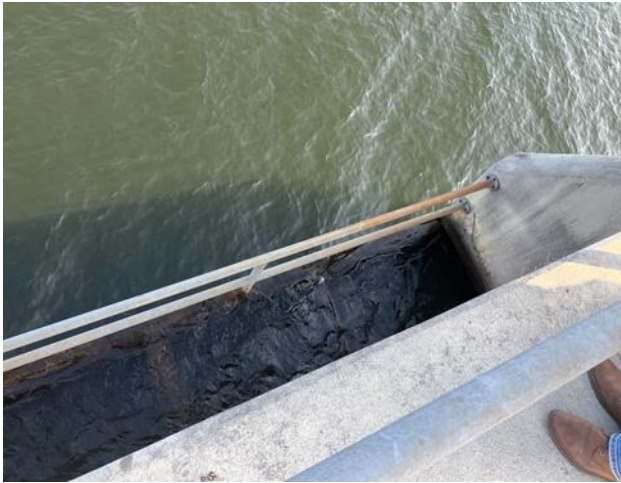
**Gates and Related Devices:** There is no record that the gates have ever been opened. The LADOTD had an independent engineering analysis and dive inspection completed on the gates in 2017. That report indicated some corrosion on the gates, missing guides on the dewatering chamber and 4.5' of silt and clay built up on the gates. It recommended not operating the gates until the silt and clay are removed.

| Type | Description | Corrective Action |
|---|---|---|
| Outlet gates | Gates are inoperable due to rusted guides and silt build up. | The LADOTD is currently evaluating repair options. |

**Comments:** The LADOTD is currently evaluating repair options.

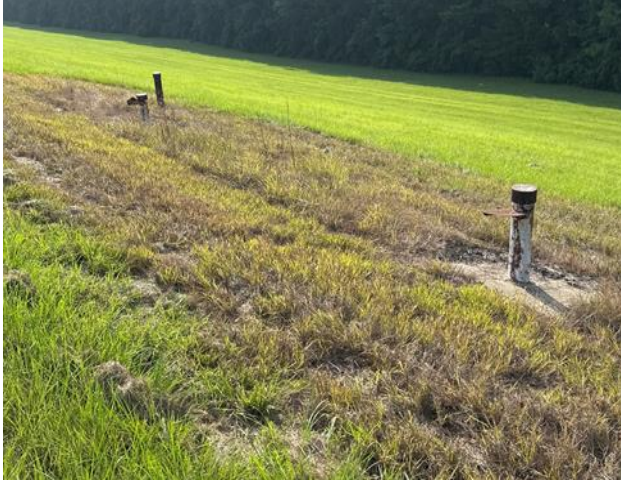
| <b>Comments:</b> | Piezometers in good condition. |

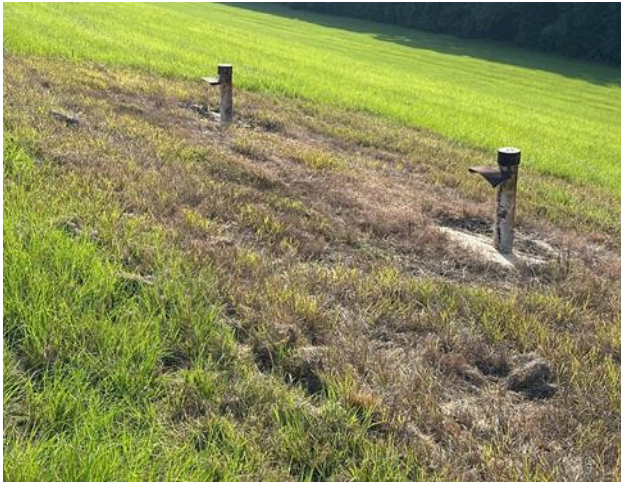
| <b>Comments:</b> | Piezometers in good condition. |

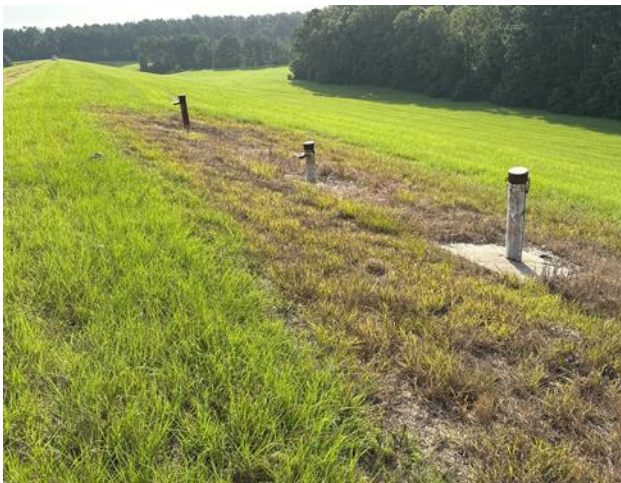
| <b>Comments:</b> | Piezometers in good condition. |

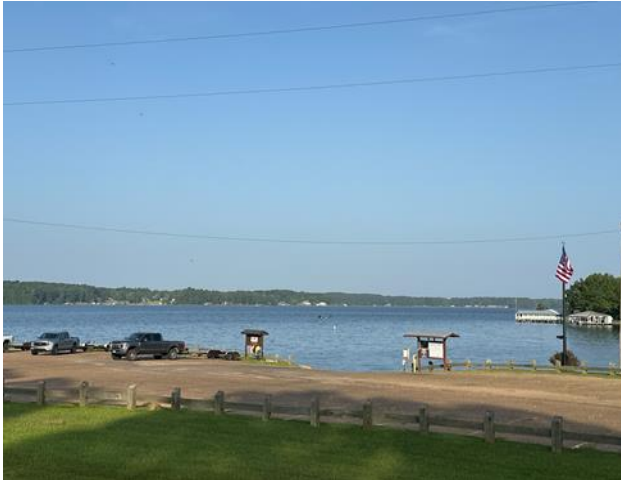
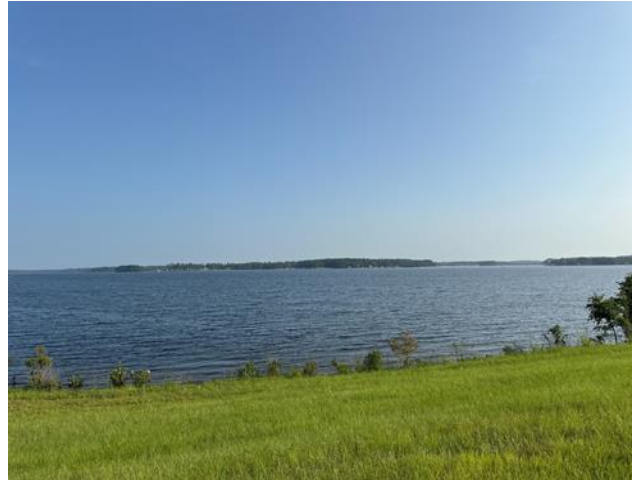
The reservoir slopes appear to be in satisfactory condition and fulfilling their intended purpose.

The reservoir banks appear to be in satisfactory condition and fulfilling their intended purpose.

There were no visible areas of sedimentation occurring within the reservoir at the time of the inspection.
